**PRELIMINARY GEOTECHNICAL AND  
INFILTRATION FEASIBILITY INVESTIGATION  
PROPOSED MULTI-FAMILY  
RESIDENTIAL DEVELOPMENT  
APNs 0410-242-03 AND -04  
HESPERIA, CALIFORNIA**

**PROJECT NO. 33979.1  
JANUARY 18, 2024**

Subject: Preliminary Geotechnical and Infiltration Feasibility Investigation, Proposed Multi-Family Residential Development, APNs 0410-242-03 and -04, Hesperia, California.

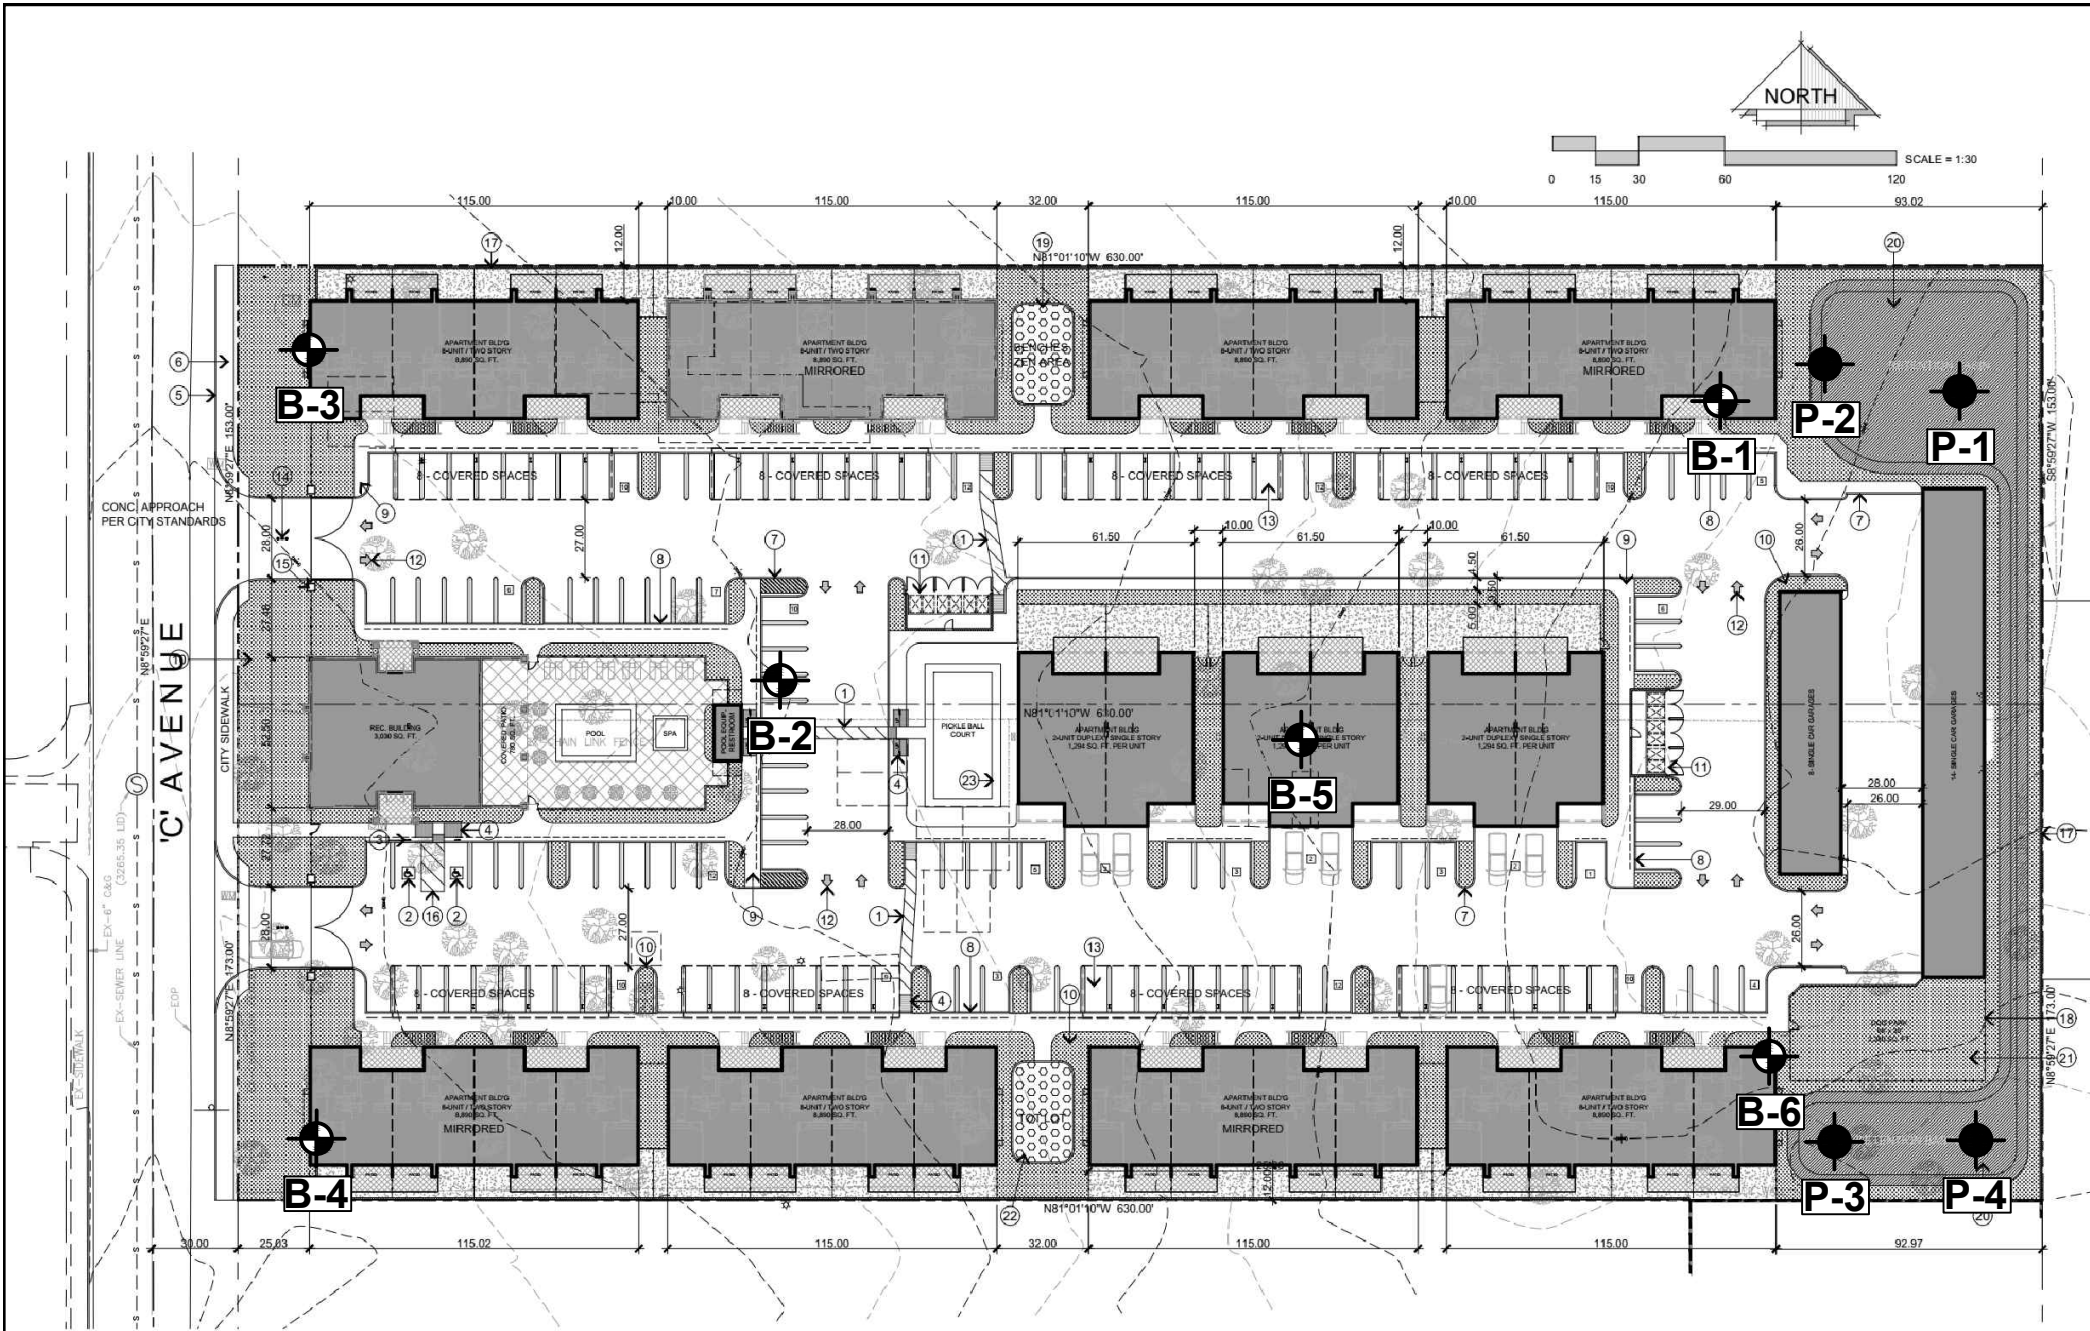
SITE PLAN  
SCALE: 1:30

To orient our investigation at the site, a Site Plan prepared by Steeno Design Studio, Inc., revised dated November 2023, was furnished for our use. The current site conditions, proposed building configurations and associated driveway, parking, and landscape areas were indicated on this plan. The Site Plan was utilized as a base map for our field investigation and is presented as Enclosure A-2, within Appendix A.

- ⊕ B-6 - Exploratory Boring
- ⊙ P-4 - Percolation Test

As noted on the site plan, development of the site will include eight, two-story apartment buildings, three, single-story apartment buildings, a recreation building, garages, a swimming pool, and associated parking and landscape areas. In addition, infiltration of on-site storm waters is proposed. The buildings are anticipated to be of wood frame and stucco or similar type construction and light to moderate foundation loads are anticipated with these types of structures.

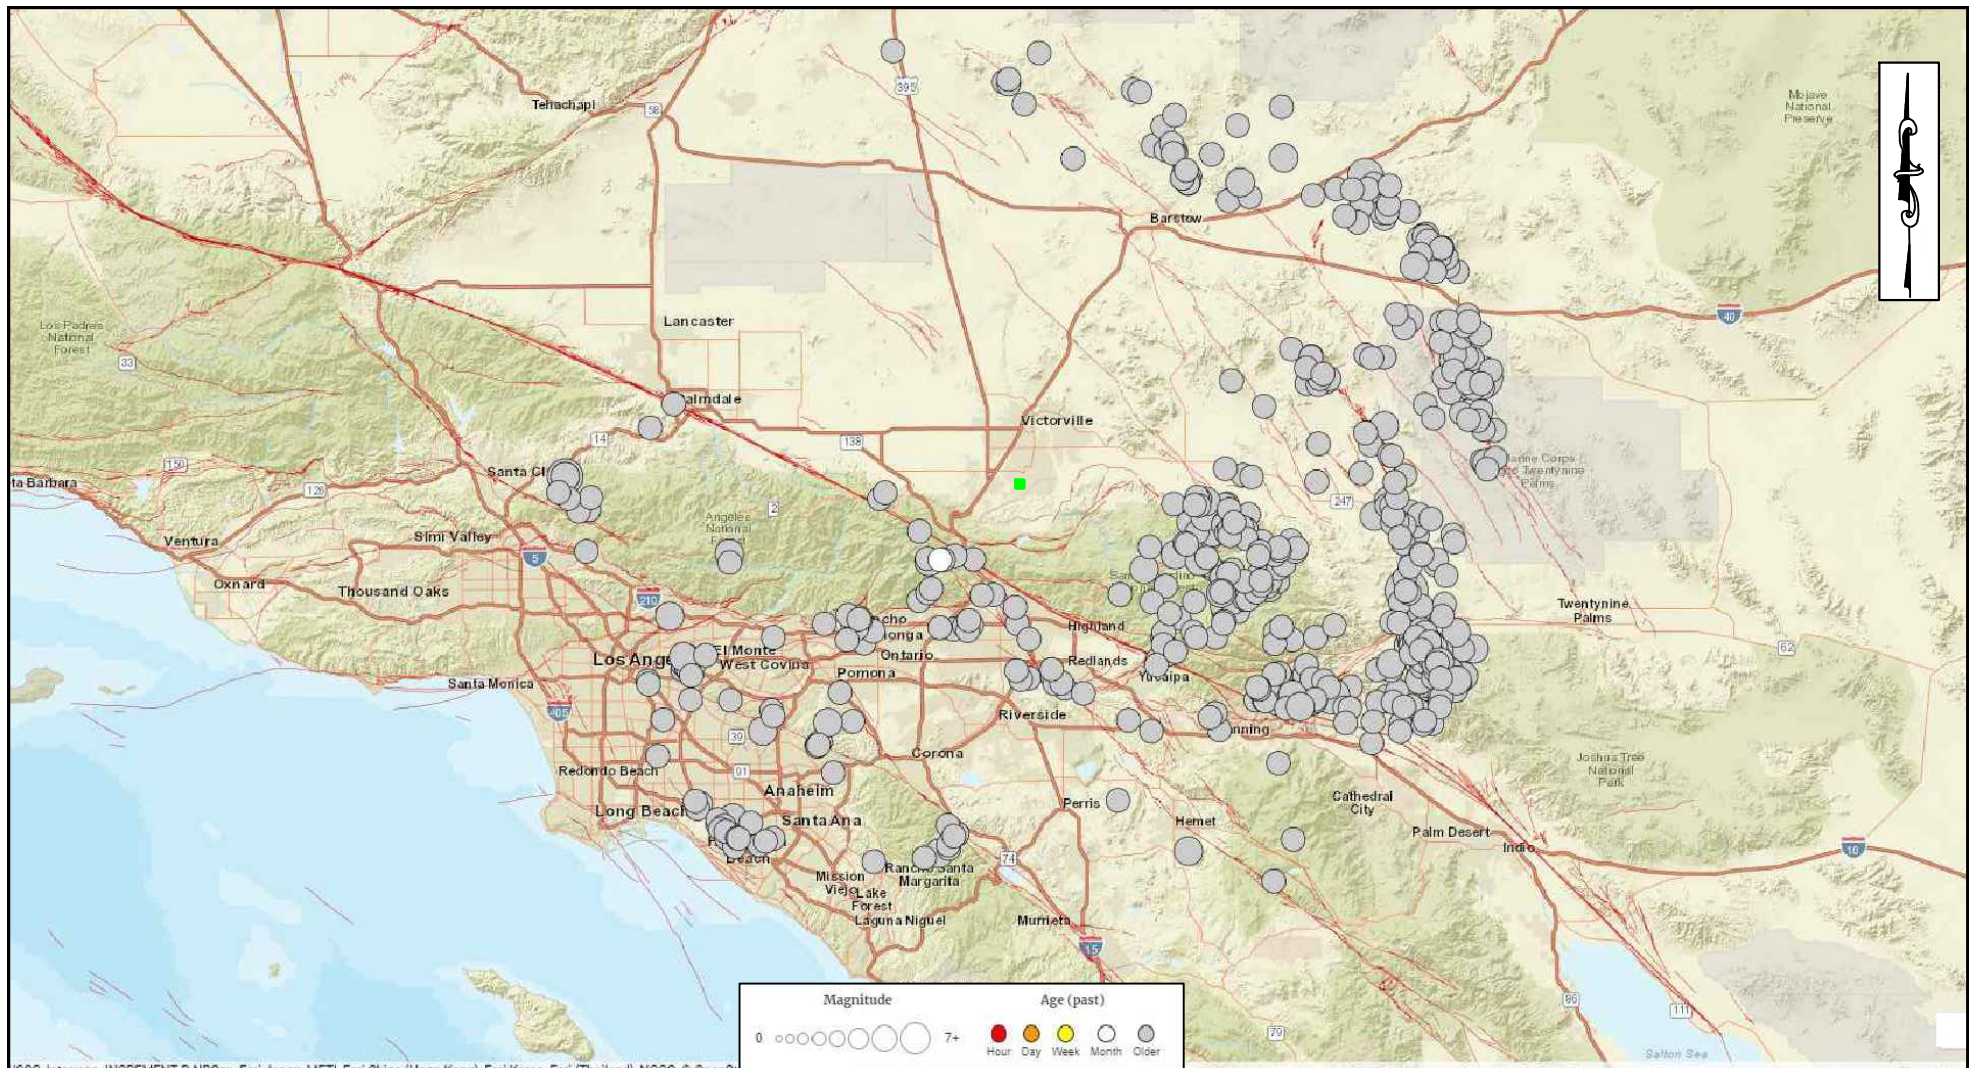
## HISTORICAL SEISMICITY MAP - 100km Radius

U.S. Geologic Survey (2024) real-time earthquake epicenter map. Plotted are 532 epicenters of instrument-recorded events from 01/01/32 to present (01/16/24) of local magnitude 4+ within a radius of ~62 miles (100 kilometers) of the site. Location accuracy varies. The site is indicated by the green square (■). The selected magnitude corresponds to a threshold intensity value where very light damage potential begins. These events are also generally widely felt by persons. Red lines mark the surface traces of known Quaternary-age faults.

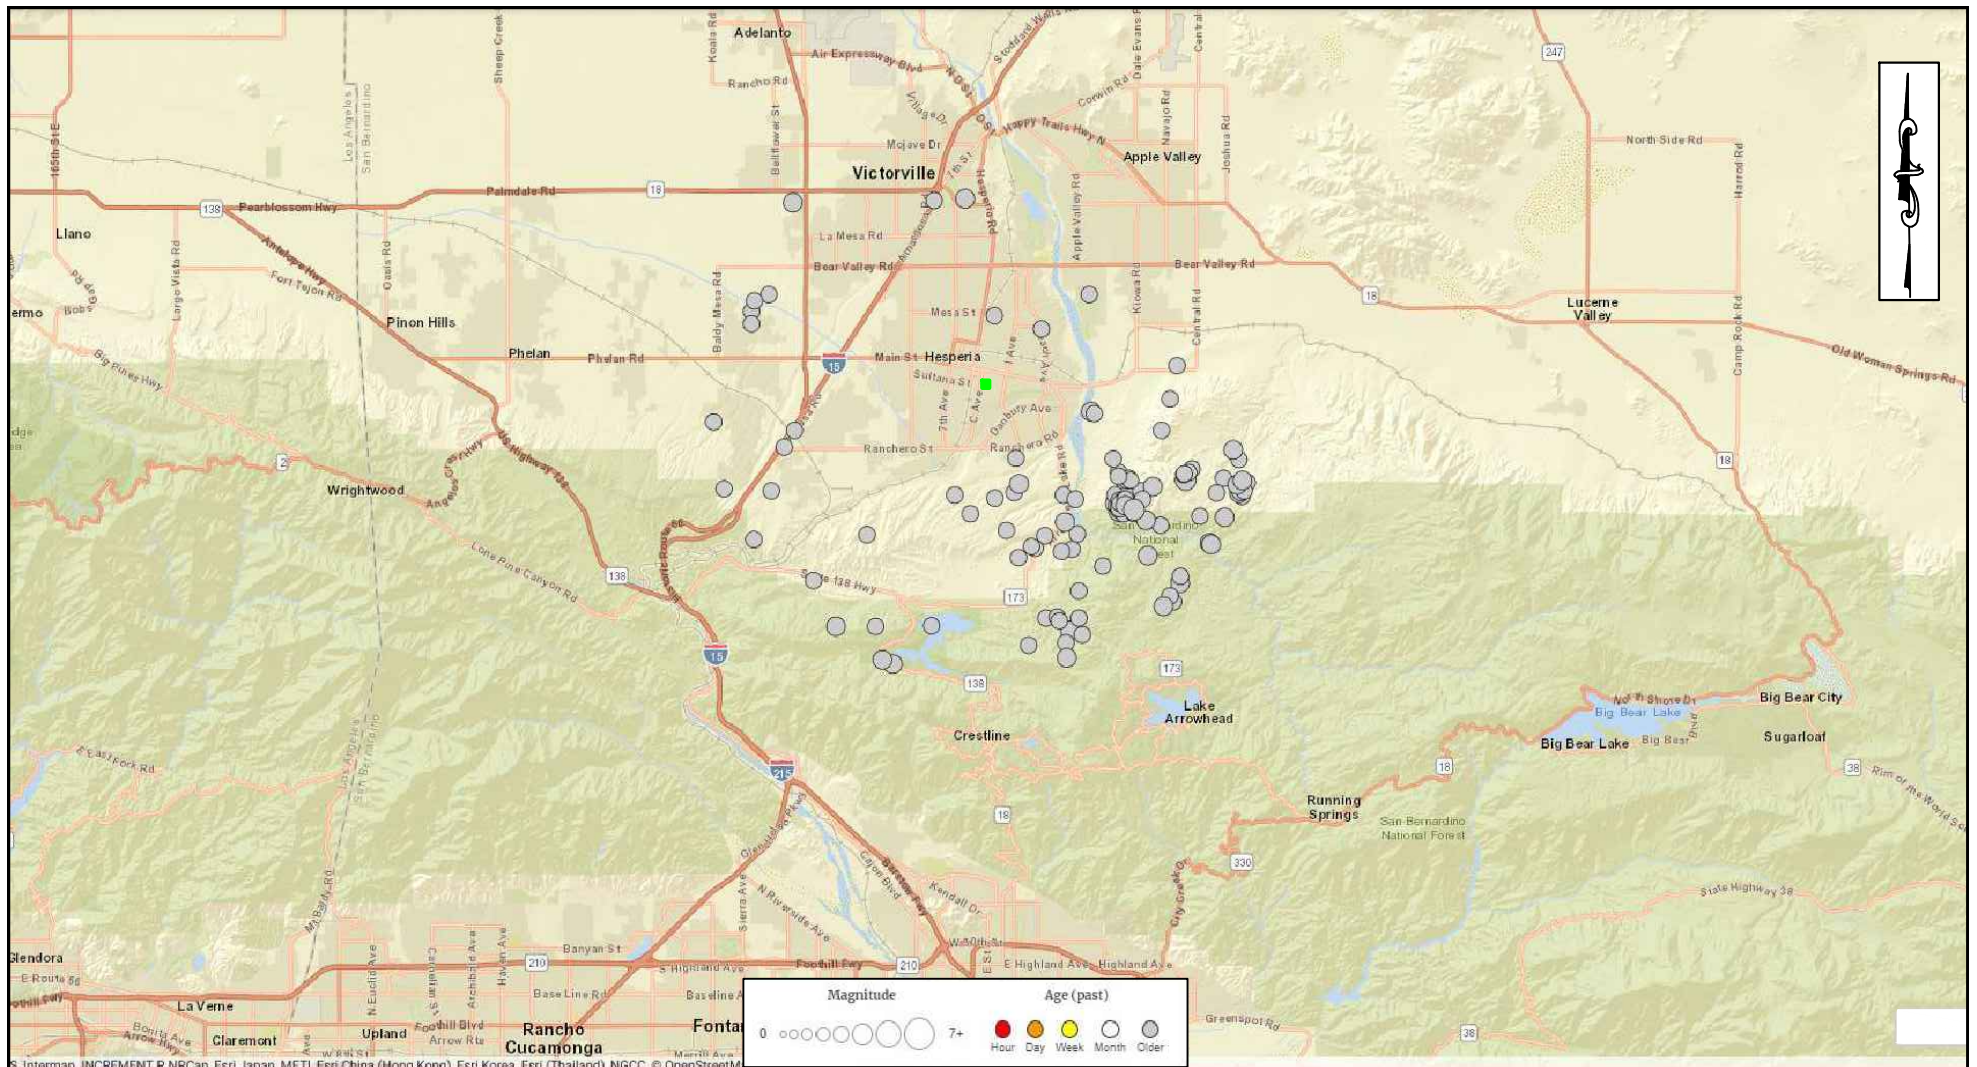
## HISTORICAL SEISMICITY MAP - 15km Radius

U.S. Geologic Survey (2024) real-time earthquake epicenter map. Plotted are 119 epicenters of instrument-recorded events from 01/01/78 to present (01/16/24) of local magnitude 1+ within a radius of ~9.2 miles (15 kilometers) of the site. Location accuracy varies. The site is indicated by the green square (■). The selected magnitude corresponds to a threshold intensity value where very light damage potential begins. These events are also generally widely felt by persons. Red lines mark the surface traces of known Quaternary-age faults.
